# Manhole Inspection Summary

Manhole # S290\_\_017MH

**Location** Address: **1143 WICOMICO**

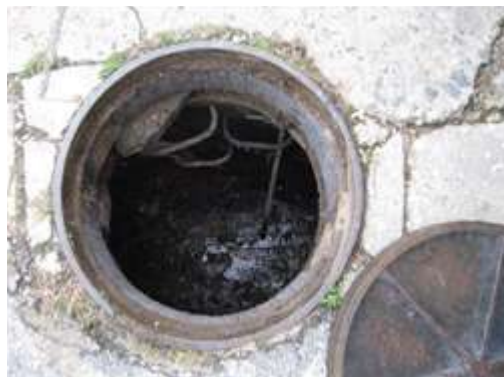
Frame View

**Frame** Offset: **0** (in.) Condition: ☐ Sound ☐ Cracked ☒ **Leaks**

Condition: ☐ Sound ☐ Cracked ☐ Root Intrusion ☒ **Loose Brick** ☒ **Deteriorated**

Infiltration: ☐ None ☒ **Joint** ☐ Cracks ☐ Mortar ☐ Roots ☐ Wall
